User Instructions for HGV Suspension Split Bush Removal & Replacement System 18797000 / 18799000 / 18798000 / 18799500

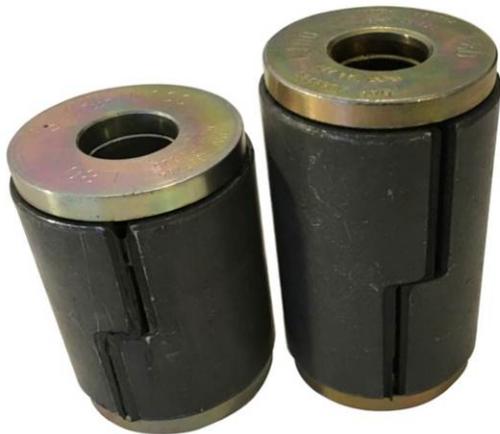
The 2 bushes in the picture are typical of the design and are both used in DAF tipper trucks where there may be more than 20 such bushes used throughout the suspension system. At each annual MOT safety check the condition of these bushes is carefully checked and if any wear is found then these must be replaced before the vehicle can be allowed back on the public roads.

Many modern trucks are fitted with SILENT BUSHES which are made up of a split outer steel casing bonded to a rubber shock absorber inner section. There are 2 steel end caps and an inner steel tube also bonded to the construction to make up the full assembly. This type of bush is hard wearing and provides flexibility within the suspension to assist in the shock absorbing qualities of the suspension. However the removal and more specifically the replacement of this type of bush is impossible without the correct equipment.

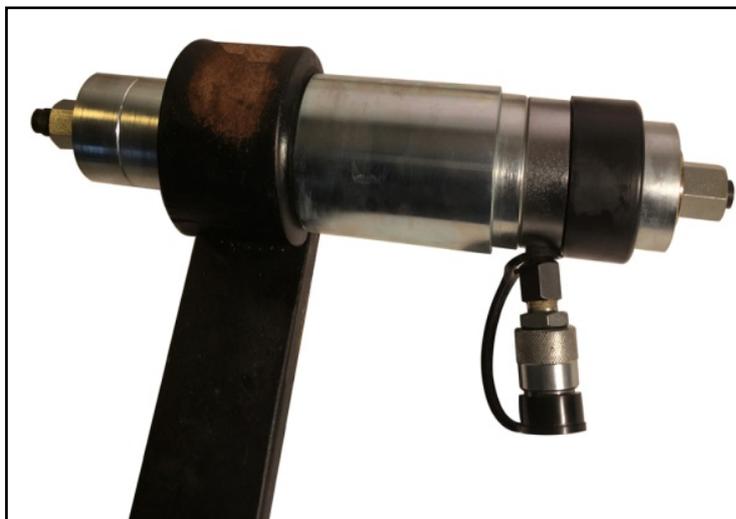
The old bush is gradually pushed out of the spring eye and is retained in the hollow receiver tube when clear of the spring. Despite the limited travel offered by this compact ram the removal is very quick using the adjustment nuts at each end of the DRAW ROD. The benefit of the compact ram is the limited space needed to operate. This more than compensates for the limited travel on each stroke of the ram.

Before the new bushes can be inserted the old worn out bushes must be removed. These can be very stubborn to remove in-situ without a great deal of preparatory disassembly work to allow clear access. The Sykes-Pickavant HGV SUSPENSION BUSH REMOVER & REPLACER system uses a compact 12 Tonne hydraulic ram extraction system to allow the operator to work in a limited access environment and so reduce the amount of disassembly work required.

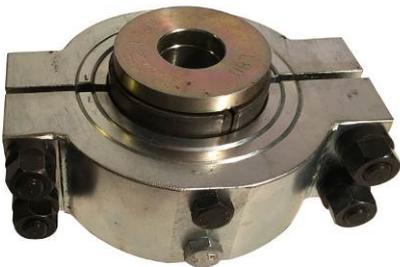
Clamp with No 1 SHELLS (75mm dia) & No 6 SHELLS (63mm dia) fitted and DAF bush in place ready for insertion. Note the tool will be set up from new in this configuration, this is to ensure all component parts are present and in position.

The second set of sleeves is retained by longer M8 bolts which pass through the outer sleeves to screw into the inner sleeves. They are coloured black or silver to identify.

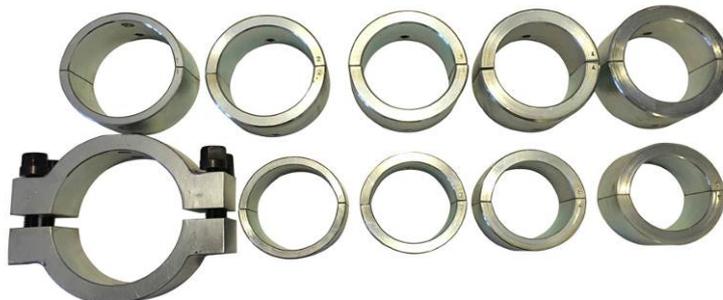
The picture below shows the full range of SHELL sleeves available with the universal clamp system.

The SHELL sleeves shown will cover the following applications: (note sizes are for guidance)

<u>Shell No</u>	<u>Part No</u>	<u>Description</u>	<u>Application</u>
1.	18797100	75mm Internal diameter	Mercedes Benz
2.	18797200	70mm Internal diameter	MAN
3.	18797300	68mm Internal diameter	MAN Front Spring
4.	18797400	66mm Internal diameter	IVECO Eurostar (driving cab)
5.	18797500	65mm Internal diameter	Mercedes Benz Actros, Atego
6.	18797600	63mm Internal diameter	DAF
7.	18797700	60mm Internal diameter	Mercedes Benz / IVECO Eurostar (stabiliser)
8.	18797800	58mm Internal diameter	Mercedes Benz / Volvo
9.	18797900	56mm Internal diameter	IVECO Eurostar (driving cab)

Please note SHELL No 1 acts as a sleeve when using SHELLS No's 6-9

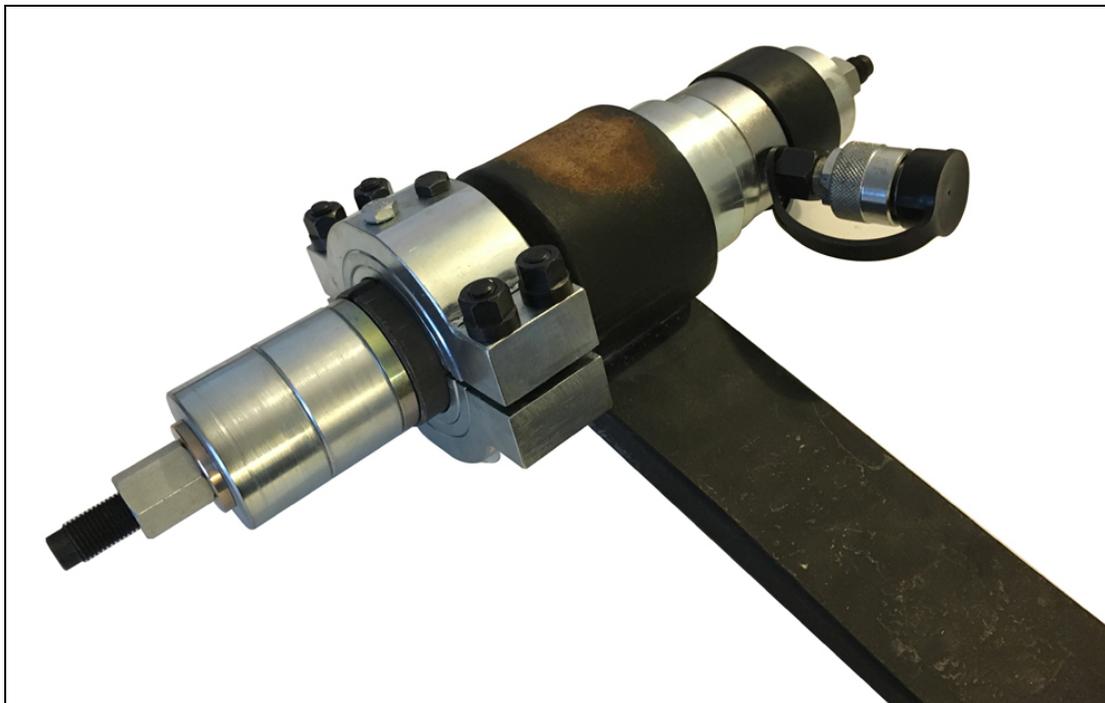
The picture above shows the full assembly prior to insertion.

As the force is applied and the bush begins to enter the spring eye the clamp will be pushed back along the length of the bush whilst still holding the bush firmly clamped to prevent the bush from breaking open under load. The process of insertion is gradual and the ram will need to be re-set a number of times, adjusting the nuts on the DRAW ROD as with the removal process. This allows for the most compact equipment operating in the limited space available.
